# 2020+ Powerstrokes

## Connectors to Keep Clean & Cover

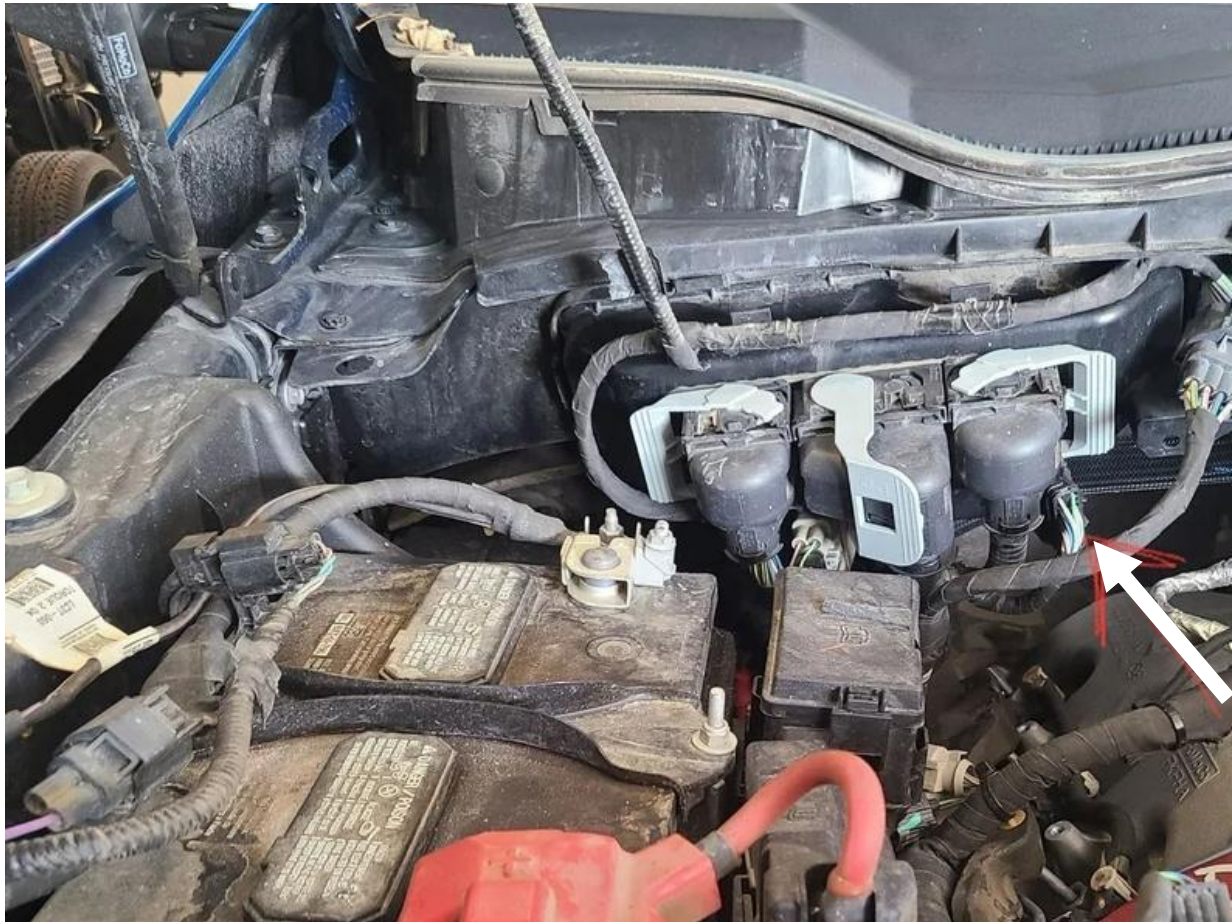
Also, please unplug the connector beside the ECM plug closest to the center of the engine. (Photo below). Customers have experienced shifting issues, transmissions stuck in 5th gear, as well as hard starting in the cold. No permanent damage has been caused, but the circuits are all connected and are causing communication issues between the modules.

It has become known that there are issues with the DPF harnesses that have been unplugged on these trucks. If you are experiencing any transmission or glow plug issues, please ensure all the connectors you have unplugged along the frame rail for the DPF are clean, corrosion-free, and greased up or sealed up to prevent any shorting. We recommend covering the connectors entirely to prevent any further problems.
